# IDT 77211 Errata

Item Number	Short Description
1	Correction to 128K x 32 SRAM memory map
2	Bus Park is not supported with random (mod 1)
3	Limitation in mixing TSRs with and without interrupt generation
4	Early frame de-assertion on latency timer expiration
5	RxSoc assertion before RxEmpty# deassertion or before RxClav assertion causes incorrect operation

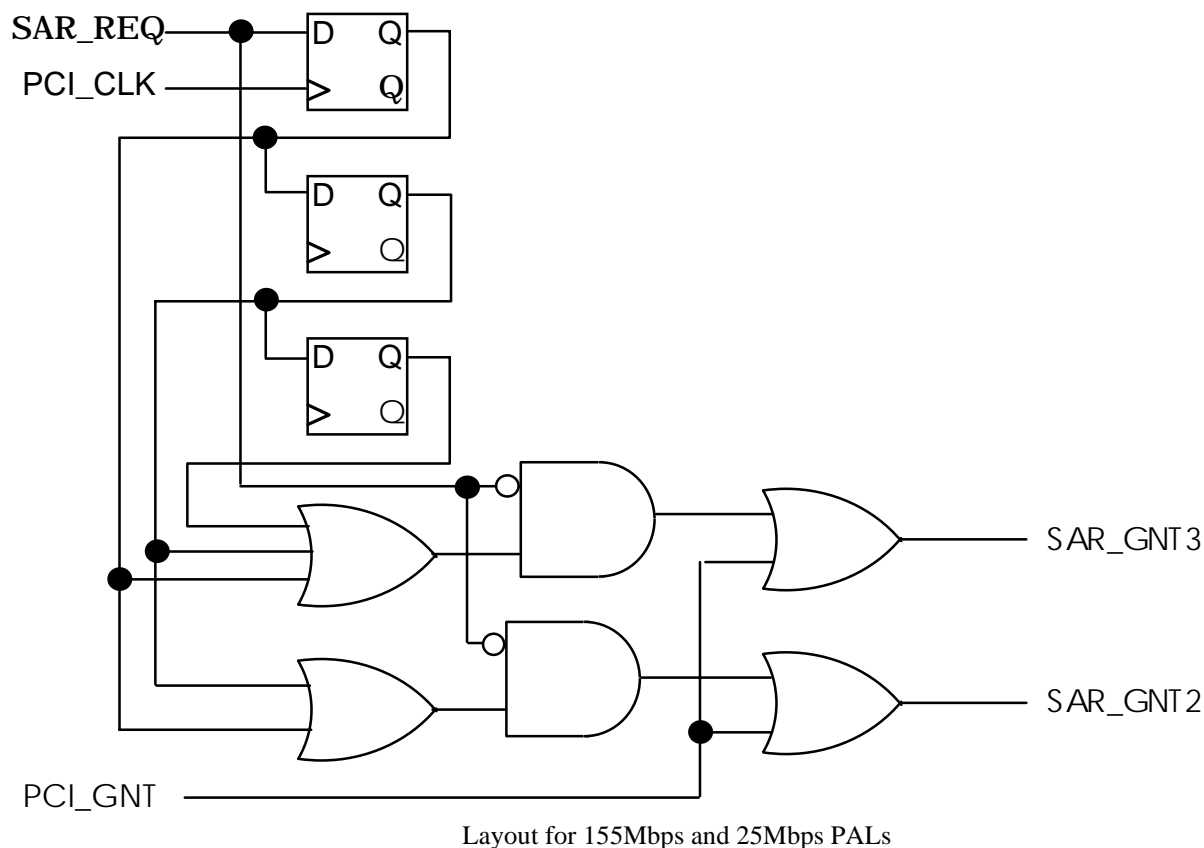
Item	Issue	Current Work Around
2	Bus Park does not work with random (Mod 1) Tx buffers. This does not effect Mod 48 or Mod 4 Tx buffers.	The addition of one of the PALs defined below.

Bus Park is not supported with random (mod 1) Tx buffers (Mod 4 and Mod 48 are not affected). Delaying the GNT signal two (155Mbps) or three (25Mbps) clocks solves this issue. This can be achieved one of the following PAL configurations:
